**Survey and Documentation Services
12th Street Landfill Site
Wilmington, Delaware**

Subject: Contract 00151122, Survey and Documentation
Services, 12th Street Landfill Site, Wilmington,
Delaware (Your P.O. #13047)

**FIELD REPORT
EXISTING STRUCTURAL CONDITIONS**

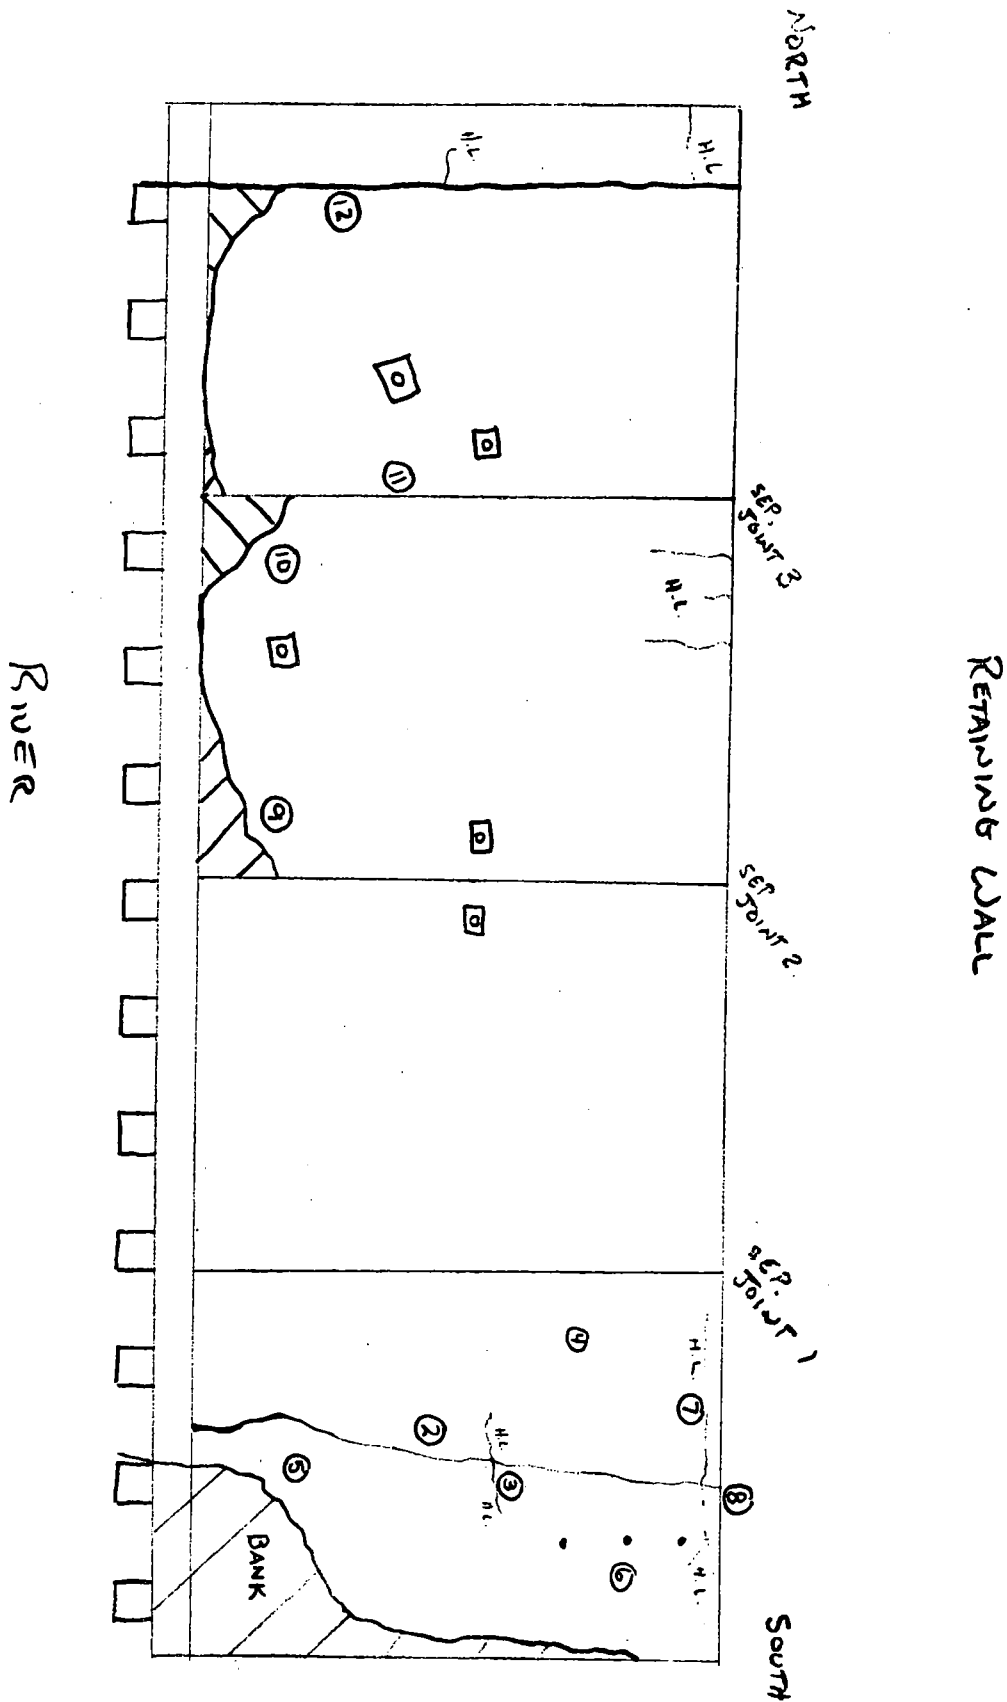
Photo Id: No. 1
Date 3/14/01

Vertical crack that extends the entire height of the wall. Located 16 ft from the north end of the wall. ~ 7'6" high, 1/4" thick
